Rubble-Mound Breakwater Stability Tests for Pier J, Long Beach Harbor, California

Miscellaneous Paper CHL-97-4
May 1997

Final report

Prepared for Port of Long Beach
Long Beach, CA 90801-0570

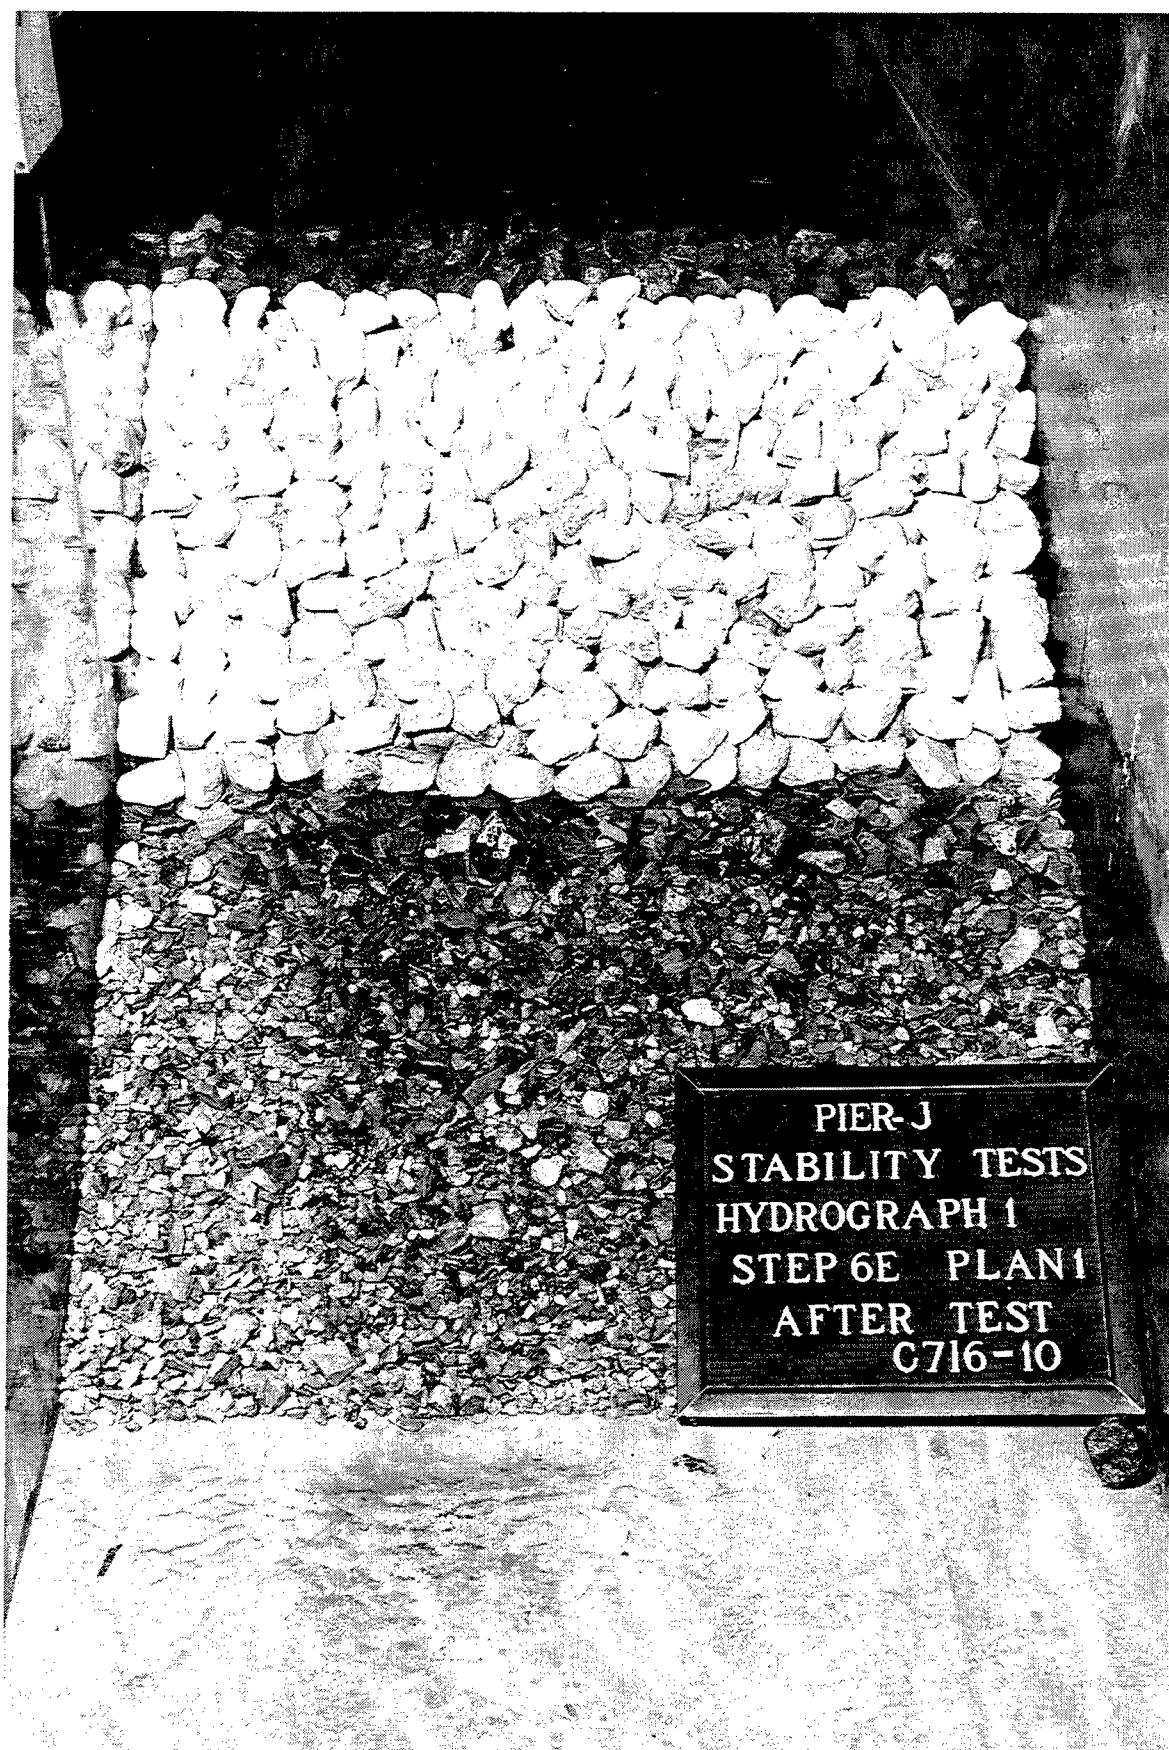
Photo 7. Sea-side view of Plan 1 after testing step 6 of Hydrograph 1

Photo 8. Harbor-side view of Plan 1 after testing step 6 of Hydrograph 1

Plan 1 exhibited an excellent stability response. Some minor reorientation of the armor was observed during steps 4 and 5. As shown in Photos 4-6, no displaced damage was evident at the conclusion of step 5. Step 6 displaced three seaward armor stones from the area between mllw and the crown. This number accounted for only 0.8 percent of the original armor, leaving the structure in excellent condition at the conclusion of step 6 (Photos 7 and 8).

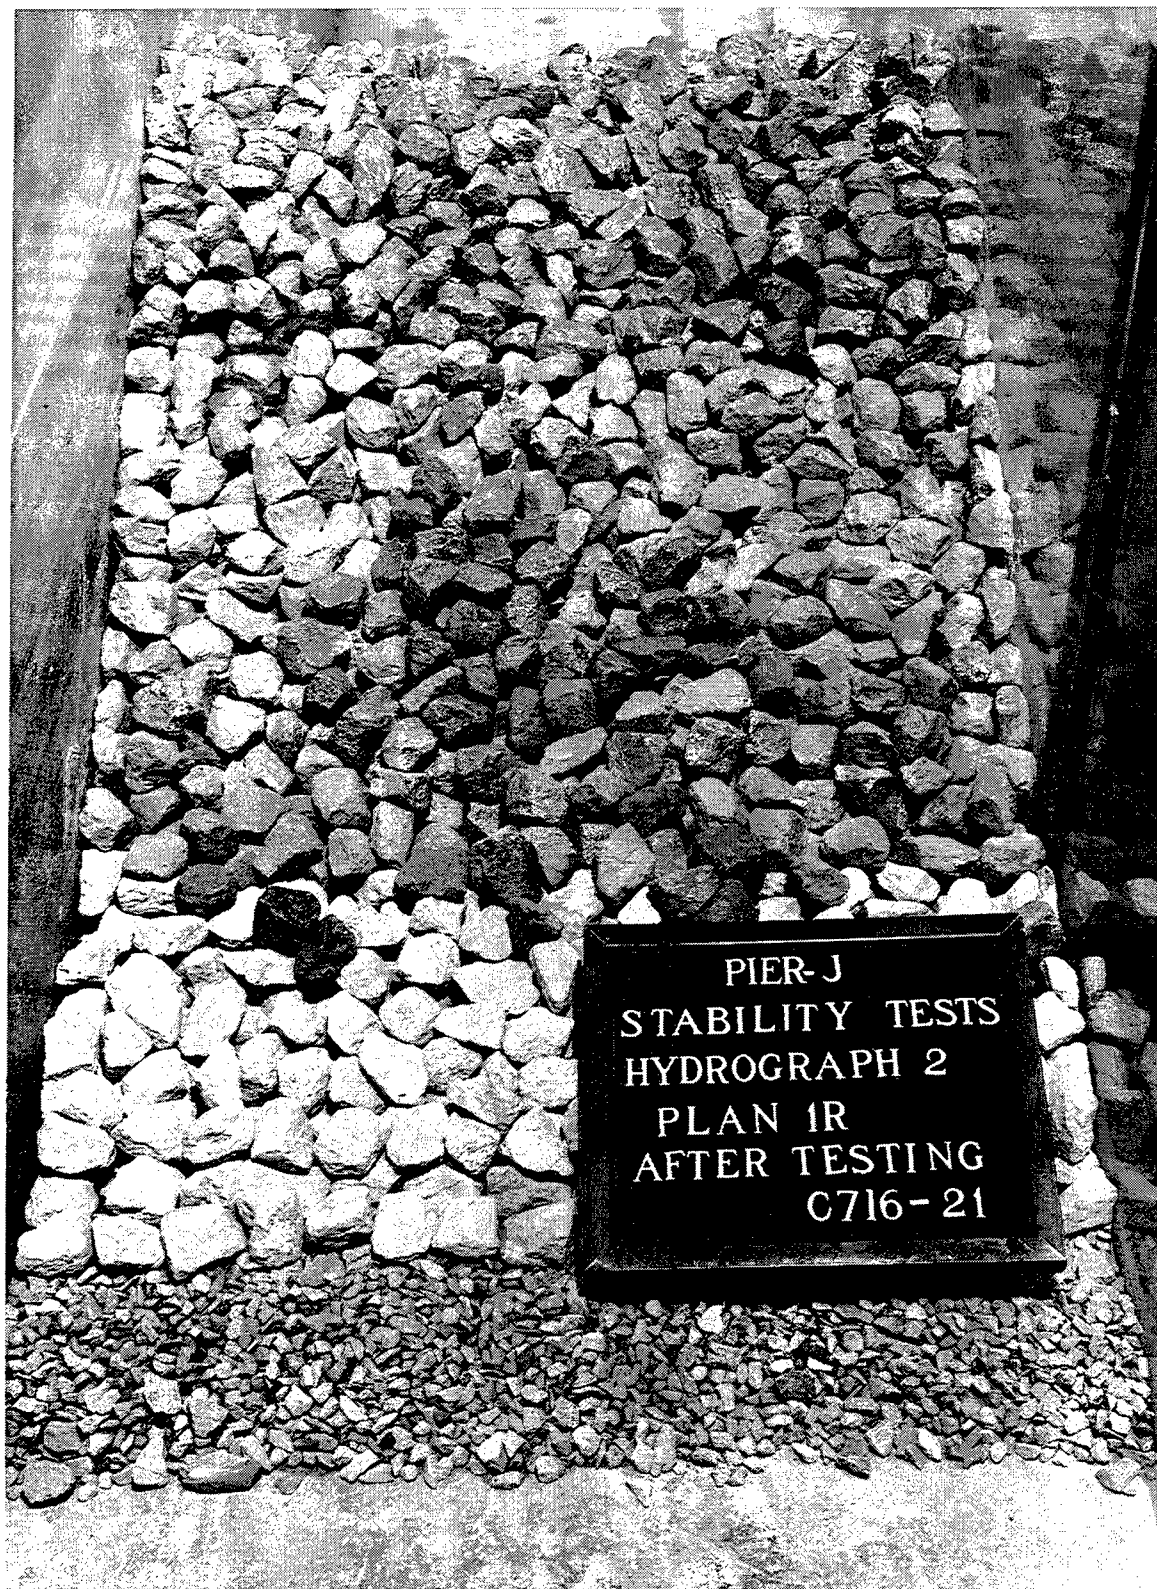
Photo 14. End view of Plan 1R at the conclusion of testing

Photo 15. Sea-side view of Plan 1R at the conclusion of testing

Photo 16. Harbor-view of Plan 1R at the conclusion of testing

Similar to the initial stability test, little movement was detected during the first four steps. During step 5, minor damage (2 percent) was incurred on the seaward face of the structure. The landward slope experienced major damage (15 percent). Photos 12 and 13 show the structure at the conclusion of step 5. Steps 6 and 7 produced little additional change except two more stones were displaced from the landward slope. As shown in Photos 14-16, step 8 produced a significant damage increase. At the conclusion of testing, the seaward armor from the area between mllw and the back of the crown had incurred 15 percent damage with stones being displaced both downslope, and over the crown. Much of the top layer of landward armor was displaced, resulting in about 40 percent damage. It is felt that the stability response in the repeat test was generally similar to the initial test, even though slightly higher damage values were observed.

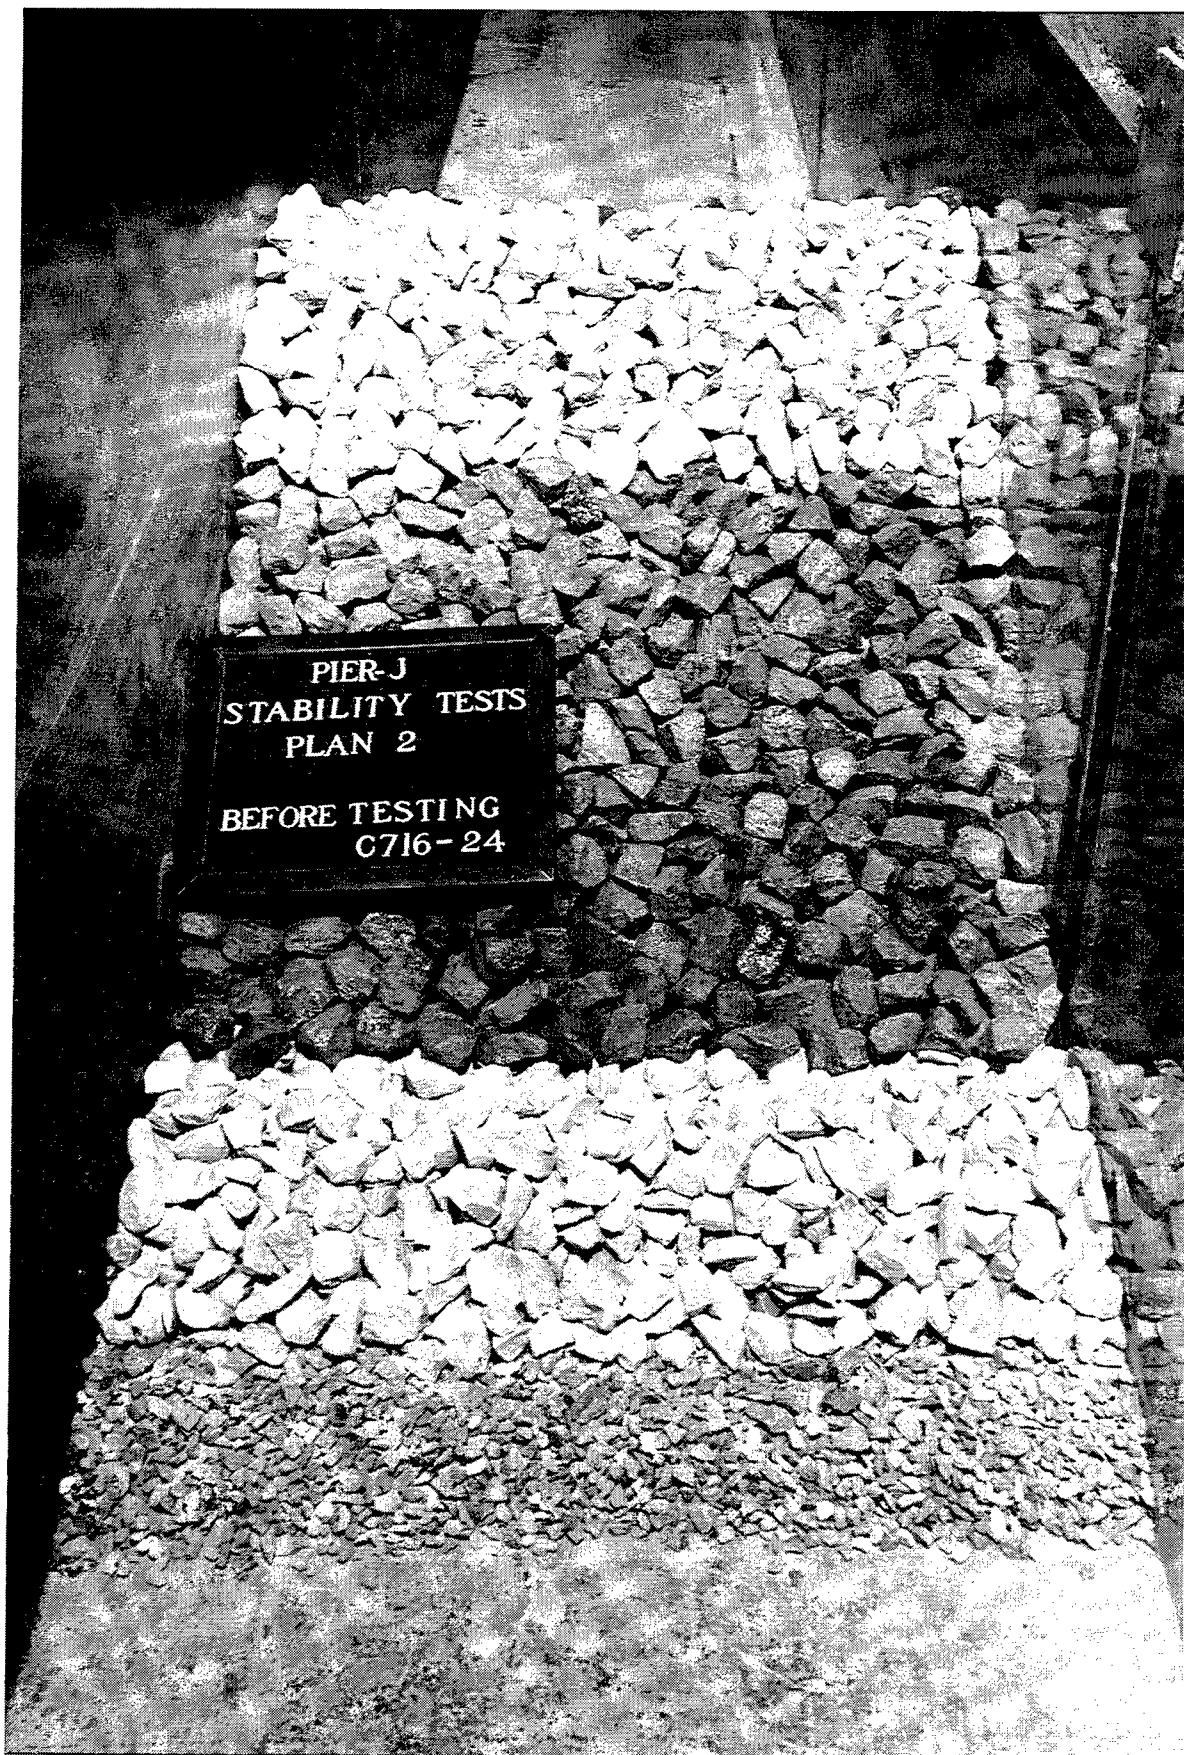
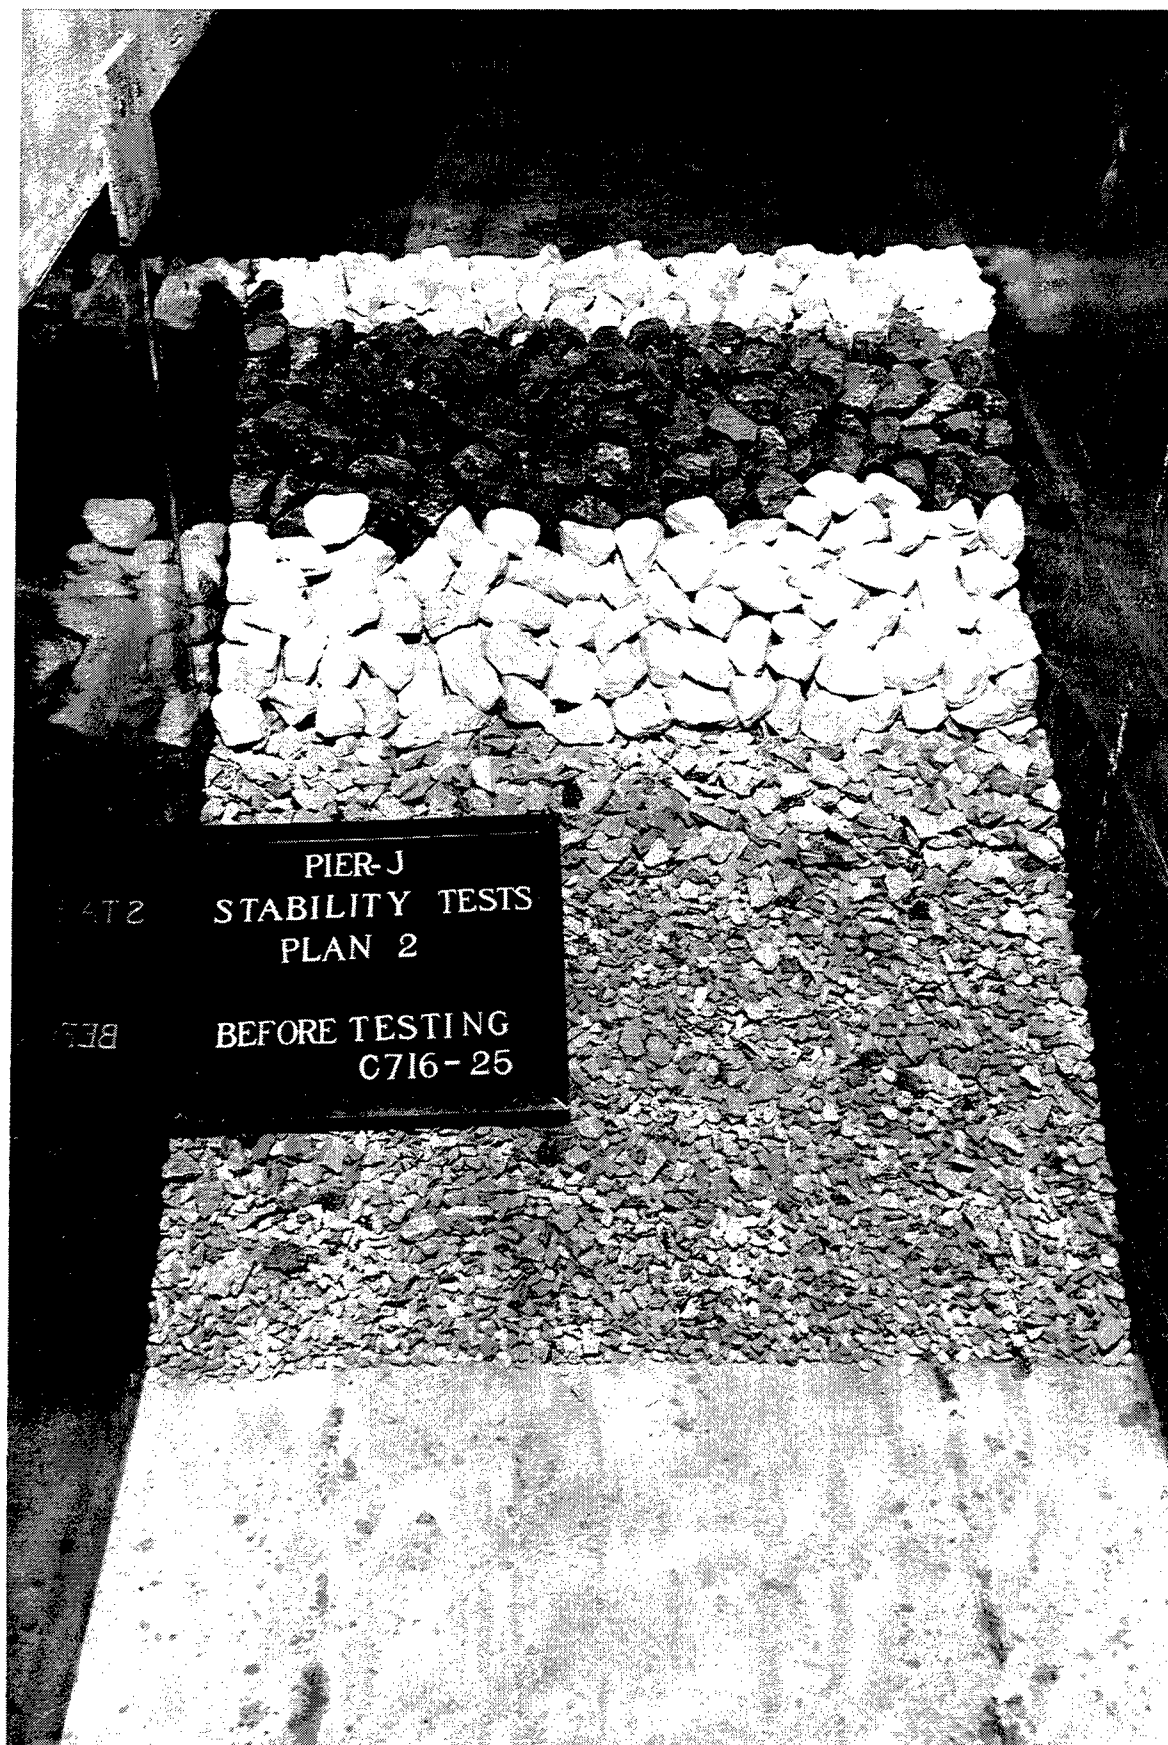
Photo 17. End view of Plan 2 before wave attack

Photo 18. Sea-side view of Plan 2 before wave attack

Photo 19. Harbor-side view of Plan 2 before wave attack

Based on the stability response of Plan 1, it was decided to investigate alternative schemes that might improve stability or reduce the structure's cost without significantly affecting its functional performance. Some of the factors that govern material volumes and costs are elevation and width of the crown, type and weight of armor, and slope on which the armor is placed. It was decided that in this particular study the greatest cost savings with the least probable impact on functionality could probably be achieved by replacing the 5- to 7-ton toe armor with 1- to 3-ton stone (Photos 17-19 and Figure 5). Also, the 5- to 7-ton landward armor between the swl and -16 ft mllw was replaced with 8- to 10-ton stone in an effort to

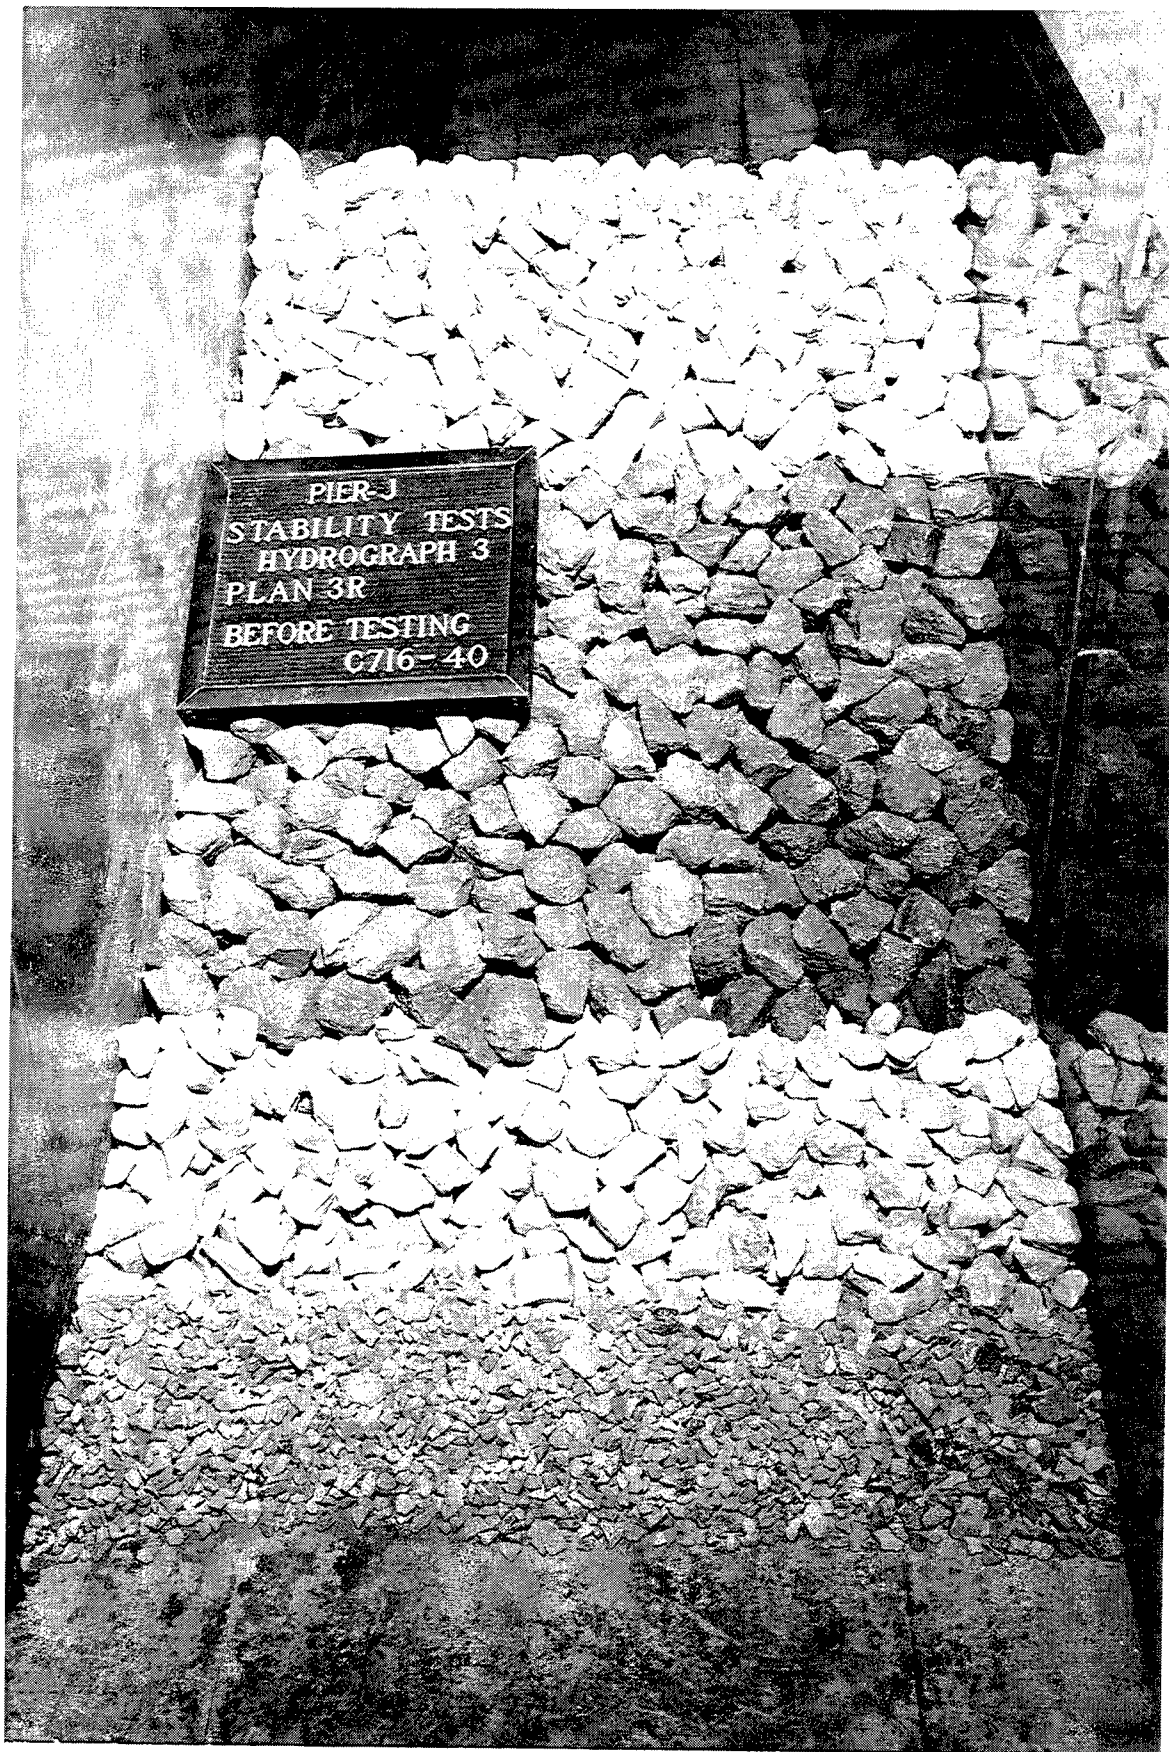
Photo 32. Sea-side view of Plan 3R before wave attack

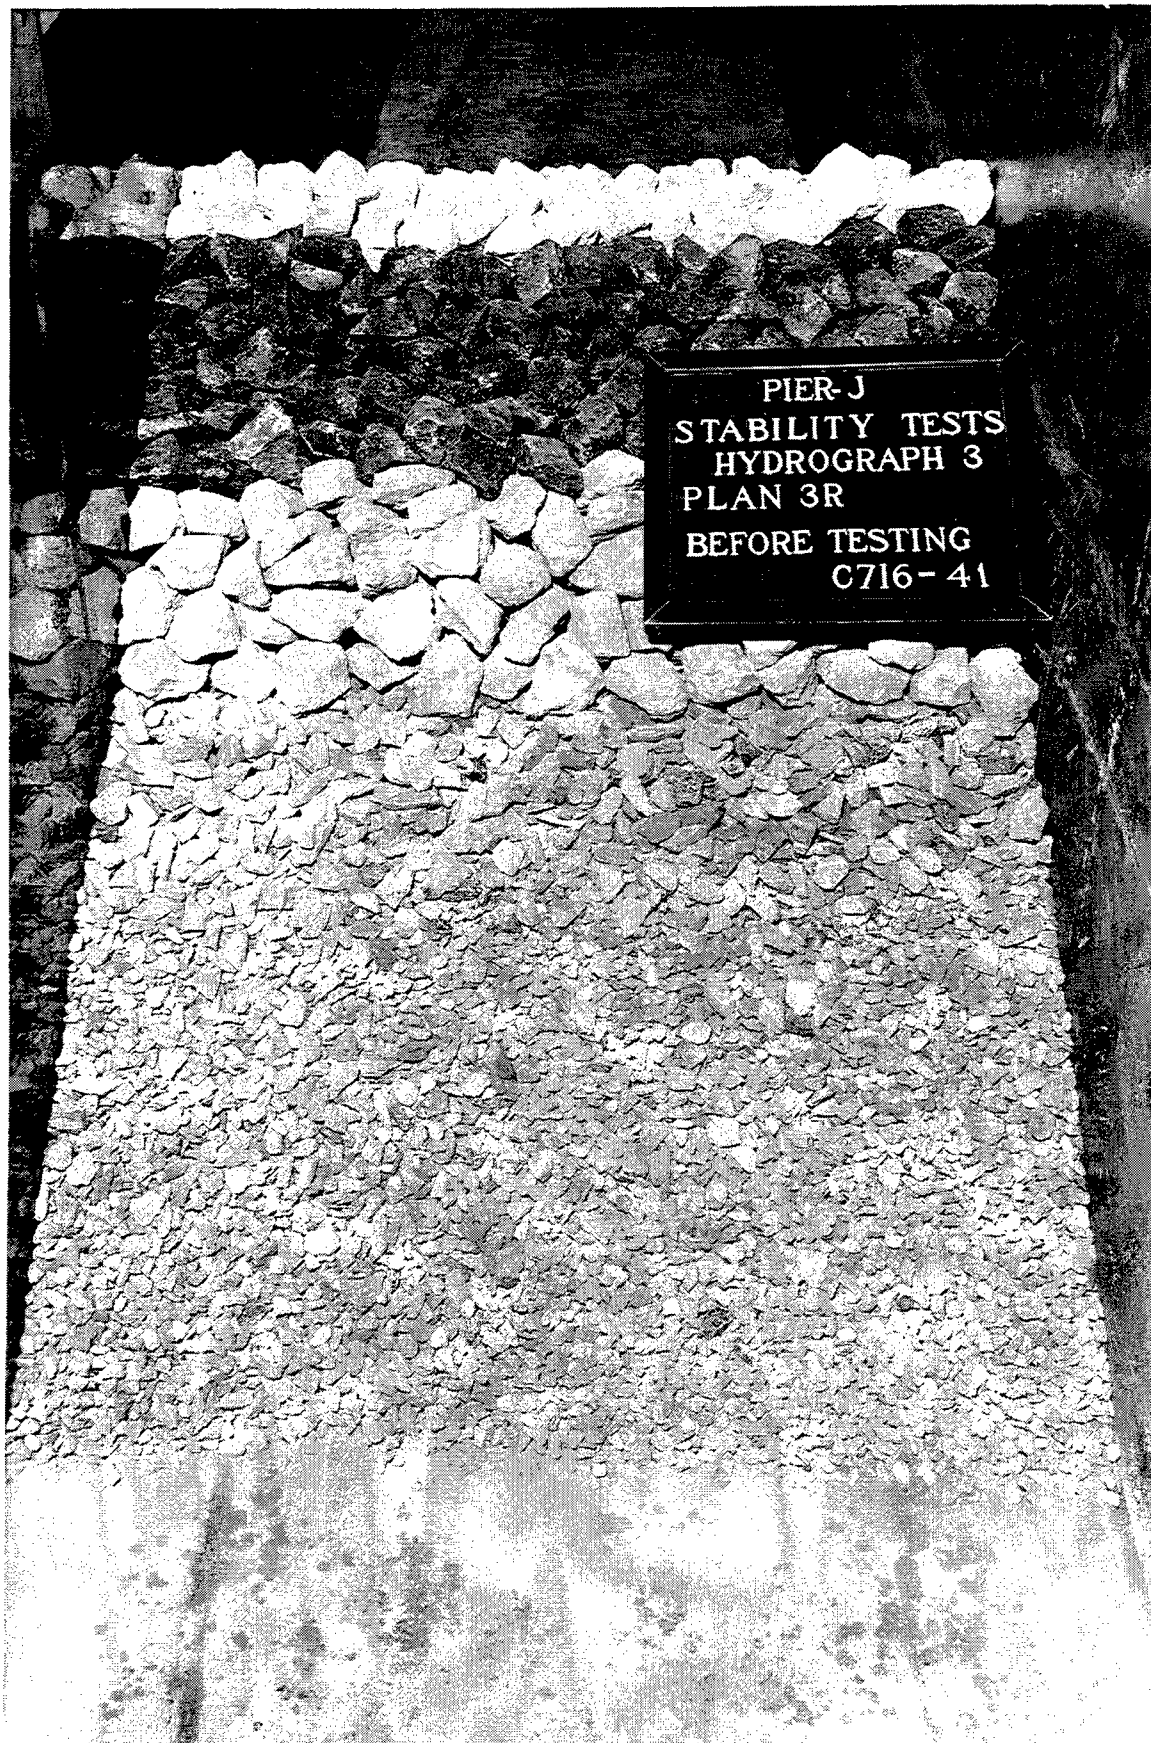
PIER-J
STABILITY TESTS
HYDROGRAPH 3
PLAN 3R
BEFORE TESTING
C716-41

Photo 33. Harbor-side view of Plan 3R before wave attack

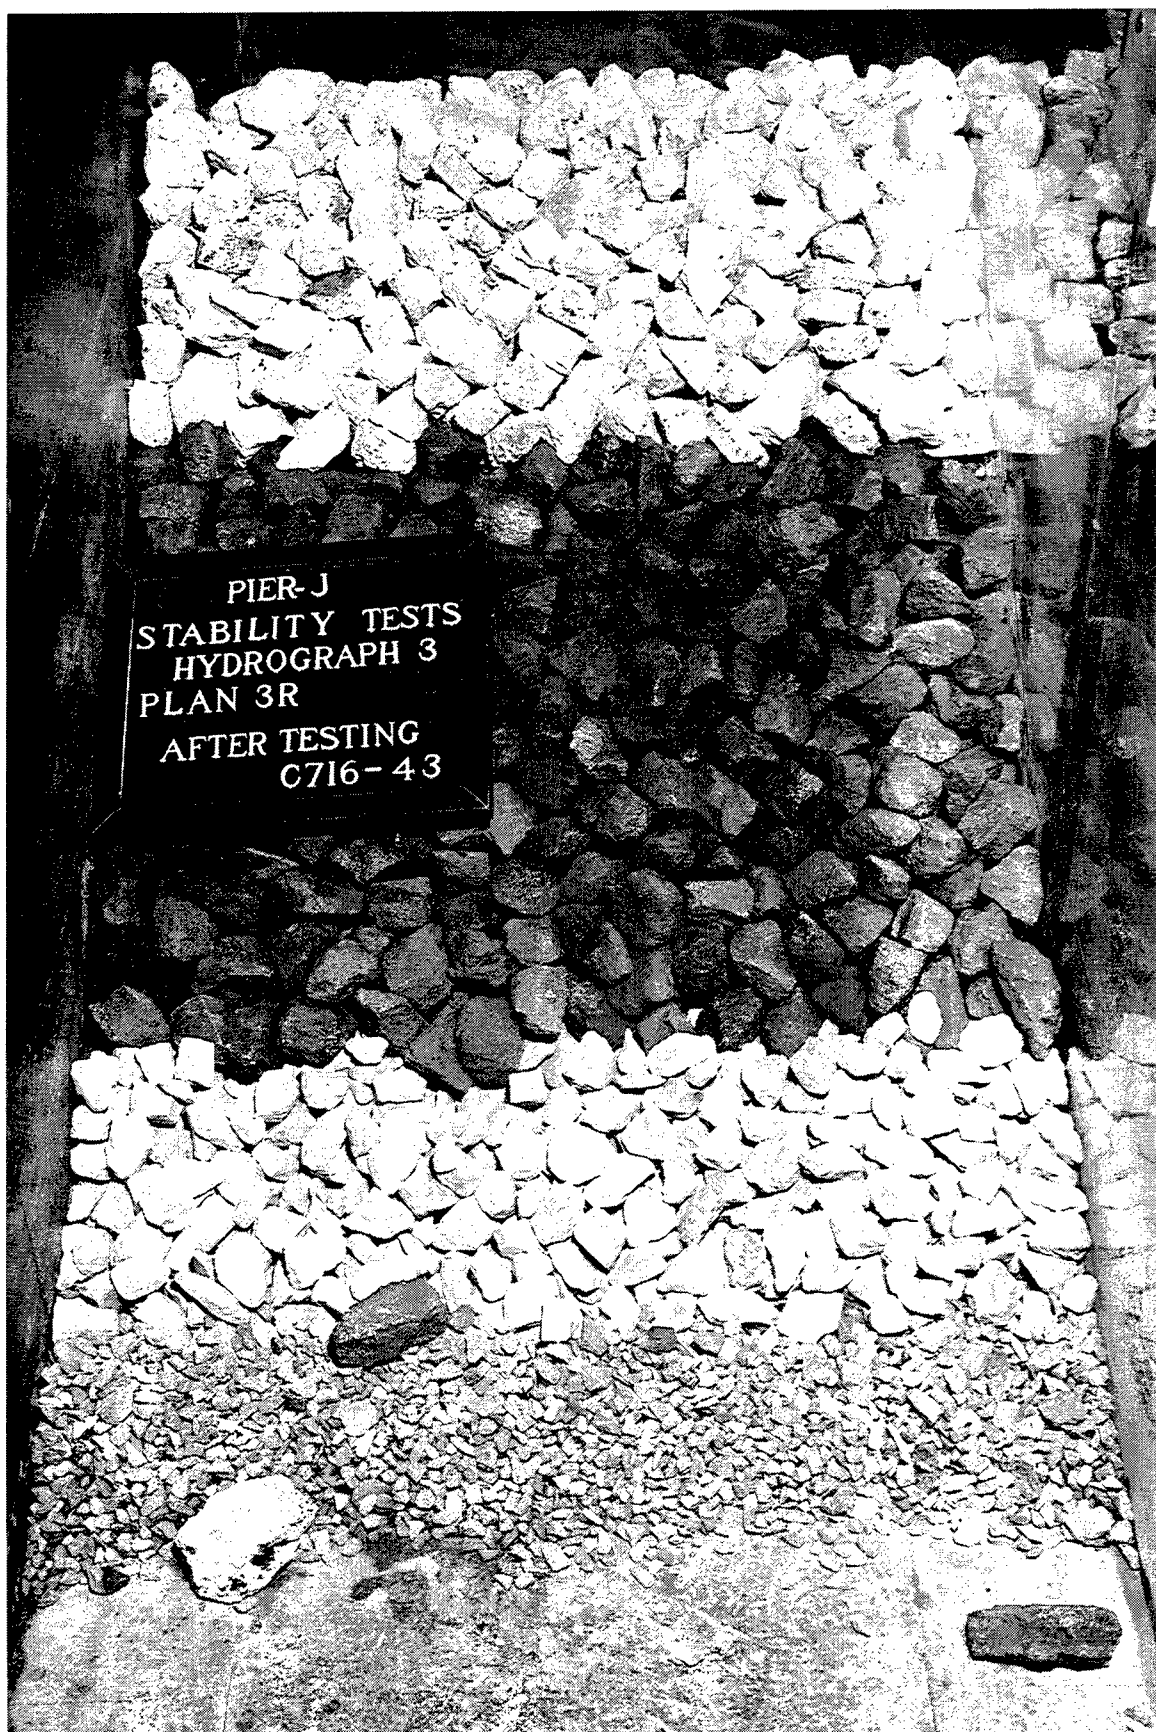
Photo 35. Sea-side view of Plan 3R at the conclusion of testing

Are test results for Plans 3, 3R, and 3R1 fundamentally different? Probably not. All plans proved stable for 13-ft waves, while only Plans 3R and 3R1 proved stable for 16-ft waves. Past work of the present authors (Carver and Wright 1991) has shown that if a large number of repeat stability tests (10) are conducted for the same armor weight, structure geometry, and spectral wave conditions similar to those used in the present investigation, design wave heights can vary by up to 30 percent within a 90-percent confidence interval. Thus, the difference in results for the three plans may well be random.

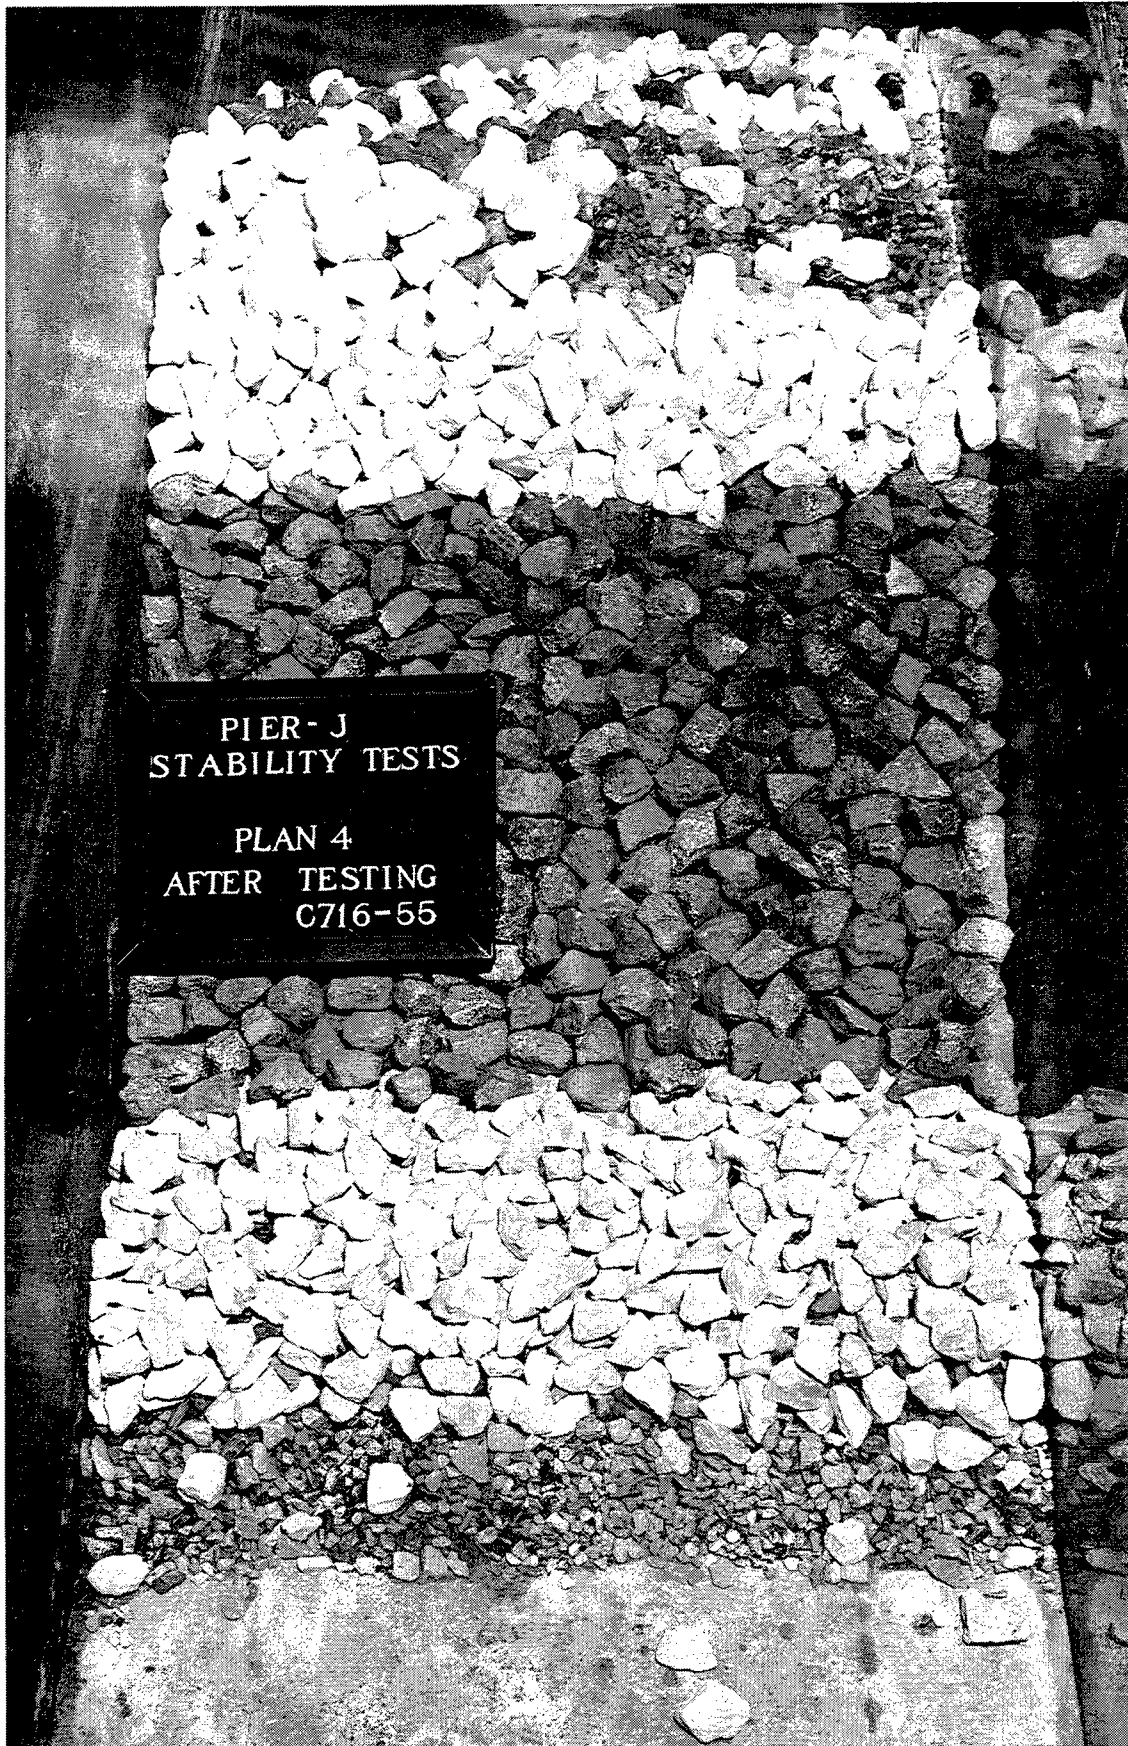
Photo 47. Sea-side view of Plan 4 at the conclusion of testing

Plan 4 was tested with Hydrograph 3. No damage was observed during the first 10 steps. Step 11 displaced three landward armor stones. No additional damage was detected for the remaining 13-ft waves. As anticipated, step 15 produced a large damage increase. Damage was estimated to be 15 percent seaward and 40 percent landward at the conclusion of step 15 (Photos 43-45). Damage progressed during steps 16-18. At the conclusion of testing (Photos 46-48), the seaward armor from the area between mllw and the back of the crown had incurred 50 percent damage and landward damage had increased to about 75 percent, with some exposure of core and underlayer near the crest.

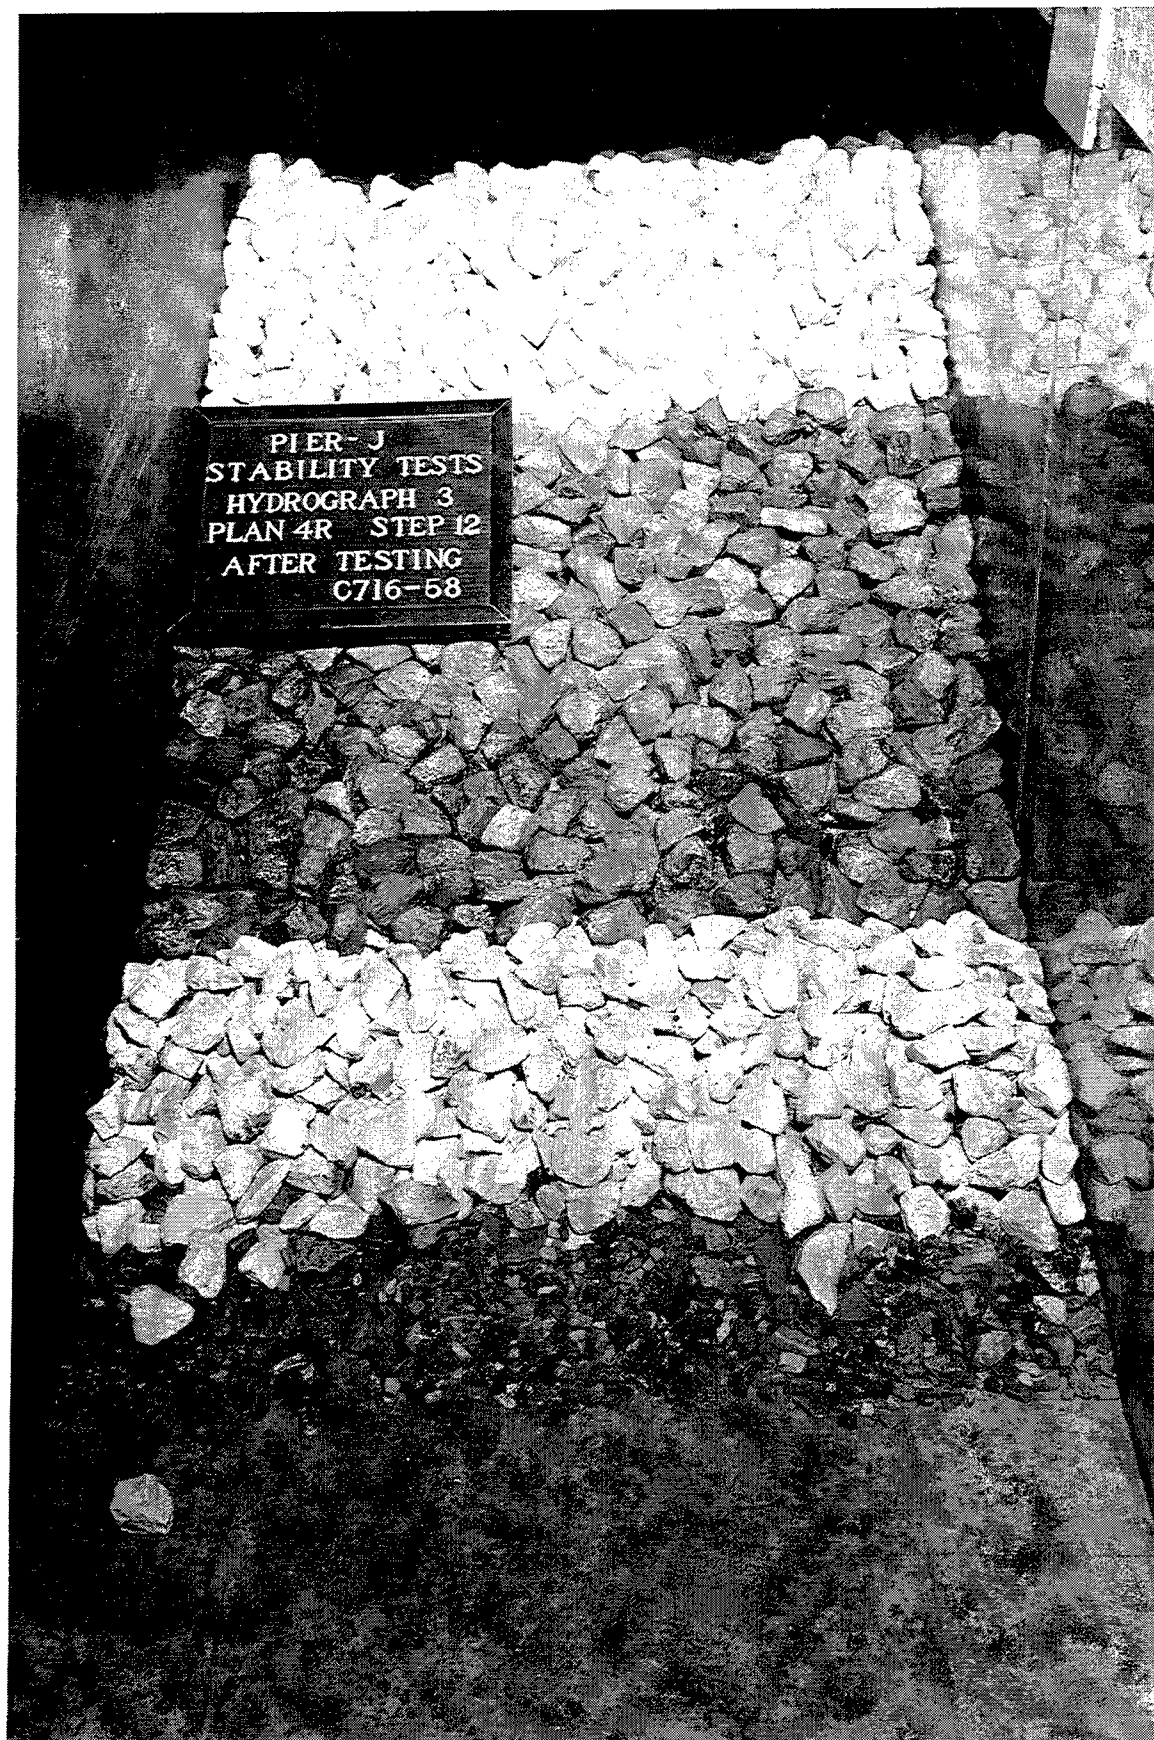
Photo 49. Sea-side view of Plan 4R after testing step 12 of Hydrograph 3

Plan 4R was identical to Plan 4. Gross statistics (T_p , H_{mo} , peak enhancement factor, etc.) of the spectra tested were the same as the initial stability test. However, as with previous repeat tests, spectral signals were randomly rephased for the repeat test. Similar to the initial stability test, little movement was detected during the first 10 steps. During steps 11 and 12 minor damage (2 percent) was incurred on the seaward face of the structure. The landward slope experienced significant damage (10 percent). Photos 49 and 50 show the structure at the conclusion of step 12. Damage continued to progress and testing was suspended after step 15. At the conclusion of testing (Photos 51 and 52), seaward armor from the area between mllw and the back of the crown had incurred about 30 percent damage and landward damage had increased to about 50 percent with exposure of core and underlayer near the crest. Initially, unexpected damage incurred for the 13-ft waves tested in steps 11 and 12 was vexing. However, inspection of the water

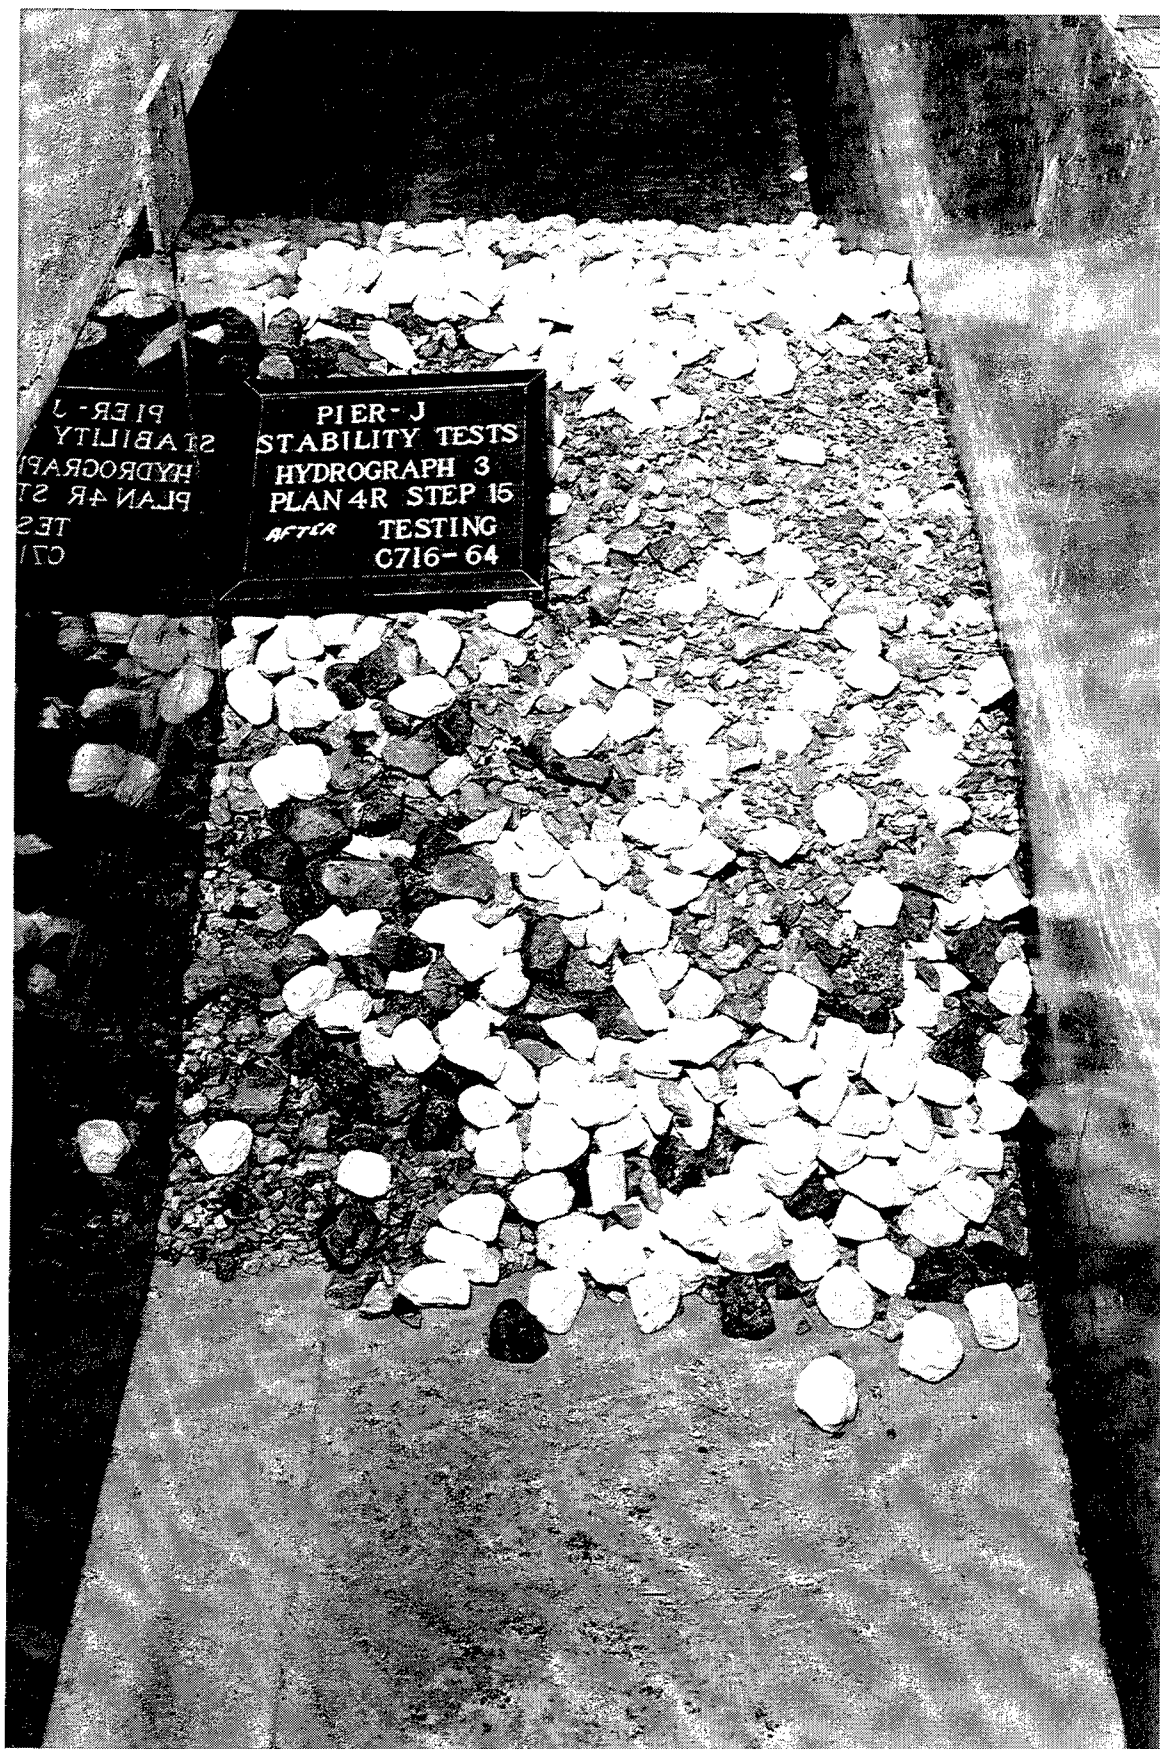
Photo 52. Harbor-side view of Plan 4R after testing step 15 of Hydrograph 3
